Subject: Boeing Submission for Asiana Airlines (AAR) 777-200ER HL7742  
Landing Accident at San Francisco – 6 July 2013

**Asiana 777-200ER – HL7742  
Landing Accident at San Francisco  
6 July 2013**

**The Boeing Company  
17 March 2014**

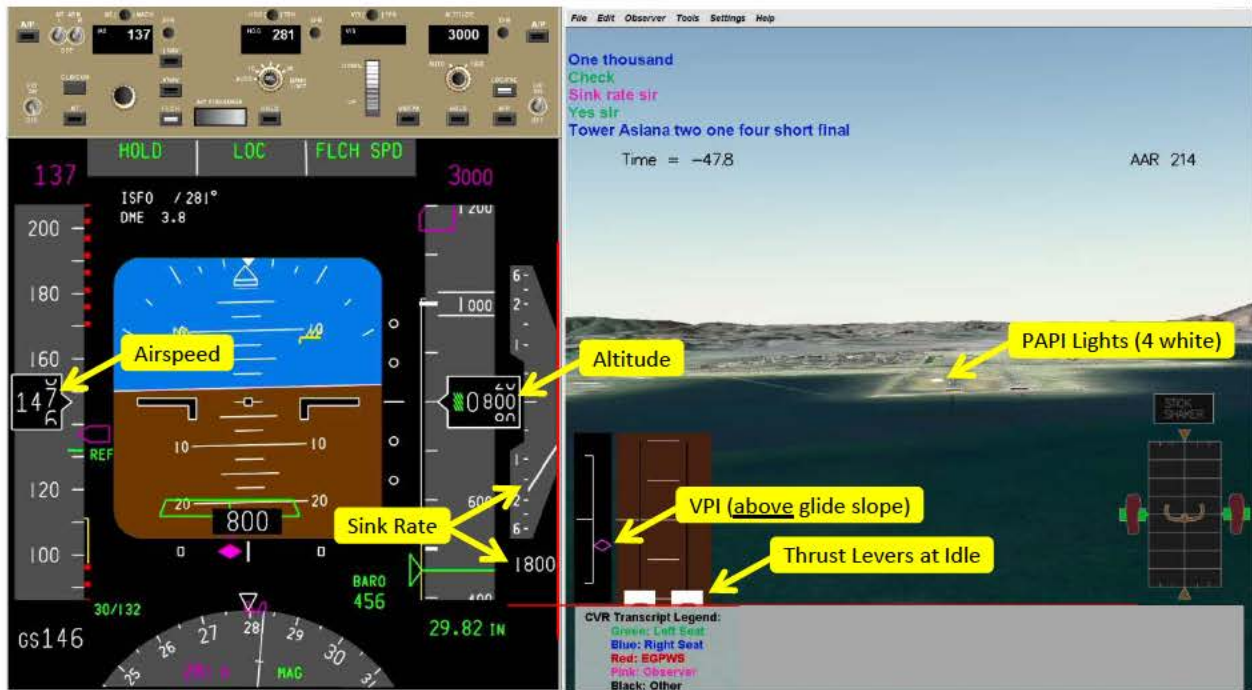
Snapshot of Backdrive Animation at 800 feet:

**Discussion:** As the aircraft descended through 900 feet to about 700 feet, the recorded sink rate peaked at 1,776 feet/minute,<sup>20</sup> in excess of the 1,000 feet/minute limit set by Asiana’s Flight Operations Manual for descent rates below 1,000 feet.<sup>21</sup> The CVR recorded that the observer First Officer called out “*sink rate*” to alert the PF and PM that the sink rate was excessive. Despite this excessive descent rate, the aircraft was still well above the glideslope. Four white PAPI lights were visible, and the VPI showed the airplane was high. Further, the aircraft’s speed was 9 knots above the MCP selected speed, even though the throttles remained at the idle stops.

**Analysis:** This represents another opportunity to recognize the issue of being high on short final and abort the landing.

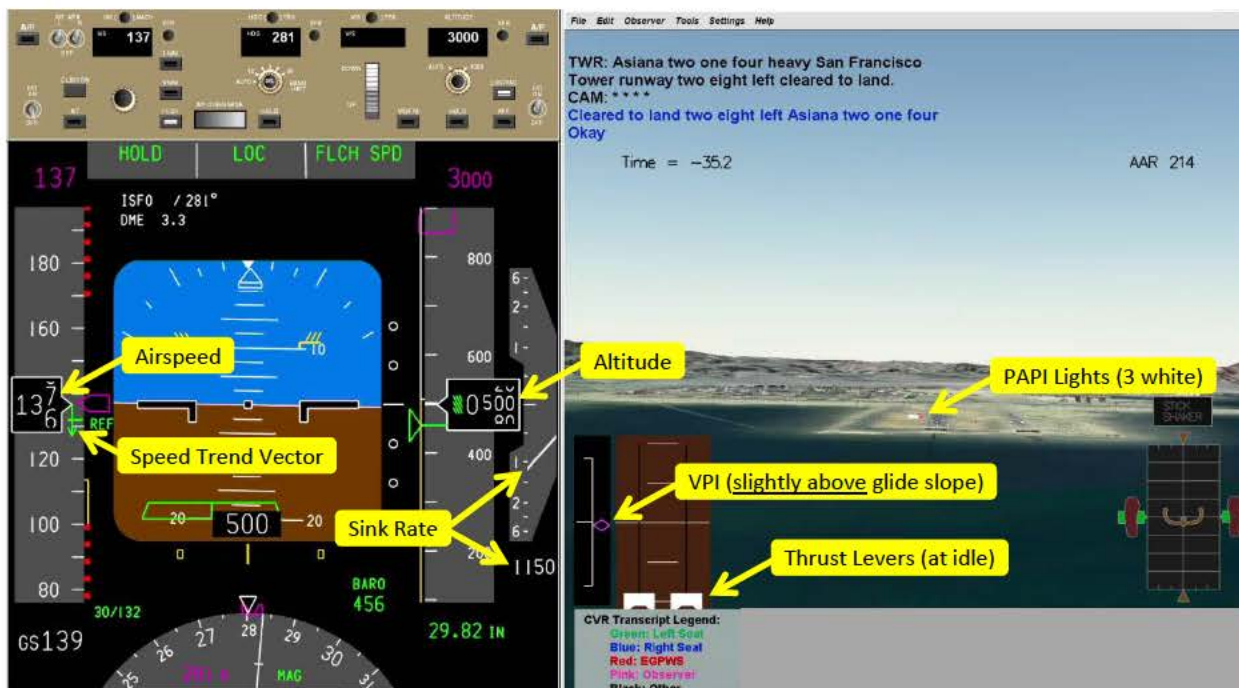
Snapshot of Backdrive Animation at 500 feet:

Discussion: This is the initial point in a visual approach (500 feet) where the Stabilized Approach Criteria began to apply for visual meteorological conditions. Table 2 (page 16) shows a summary of how the approach, at this point, compared to the Stabilized Approach Criteria. Given the failure to meet the Stabilized Approach Criteria, Asiana’s policies required the crew to conduct a go-around.

Asiana procedures require the PM to call out “five hundred” when the aircraft reaches 500 feet. At that point the PF must respond by either calling out “landing” or “stabilized” or executing a go-around.<sup>22</sup> The CVR did not record any discussion of the approach being stabilized. Nor did it record that either pilot made the callouts required by Asiana procedures. At 500 feet, the approach did not meet the Stabilized Approach Criteria and a go-around should have been initiated.

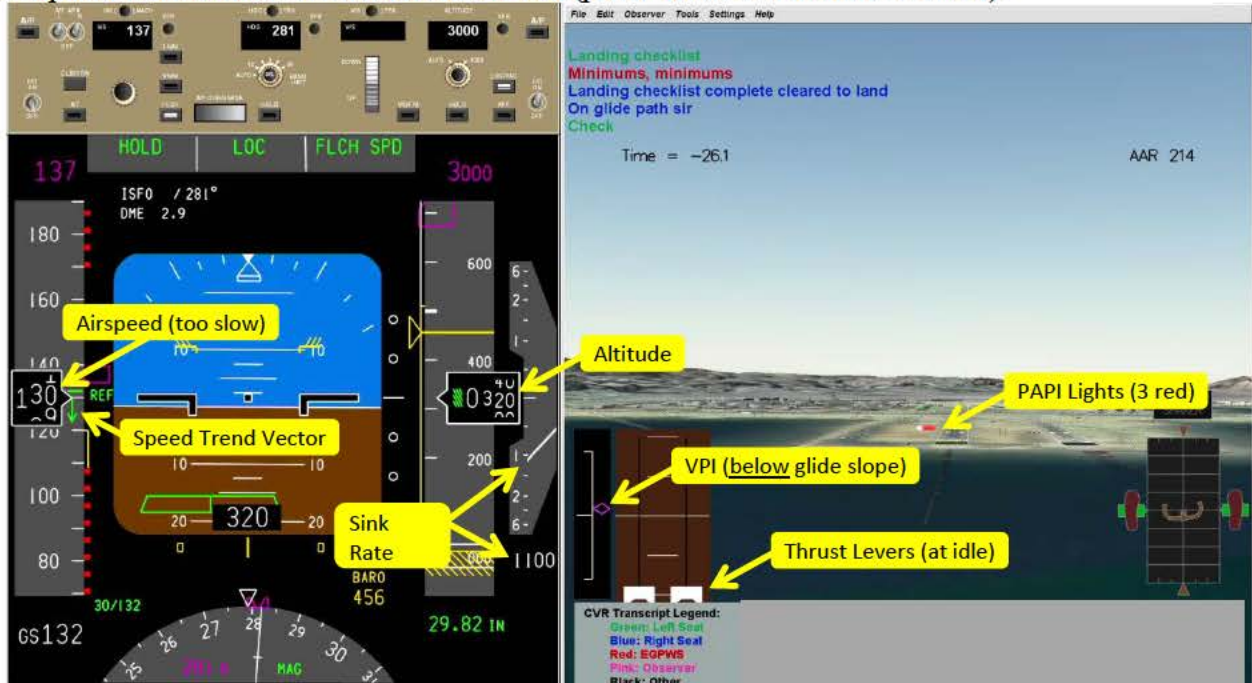
Snapshot of Backdrive Animation at 320 feet (point where PAPI showed 3 Red):

**Discussion:** About three seconds prior to the PAPI showing 3 Red, the PM said “*on glide path sir*” and the PF responded “*check.*” The PAPI then turned to 3 Red (see Appendix 1, Plot 5). The approach was progressively becoming more unstable: the thrust setting was not correct, airspeed was low and decelerating, and sink rate remained excessive (see Table 2, page 16). There was no recognition or discussion on the CVR of any of these issues.

During the NTSB public hearing, Asiana’s 777 Chief Pilot stated that, under Asiana’s policies, if the flight crew sees 3 red PAPI lights, the PM should call out that the aircraft was low, and the PF should take immediate action.<sup>23</sup> Further, Asiana’s policy expressly states that “...an approach that becomes unstabilised below ... 500 feet AFE in VMC requires an immediate go-around.”<sup>24</sup>

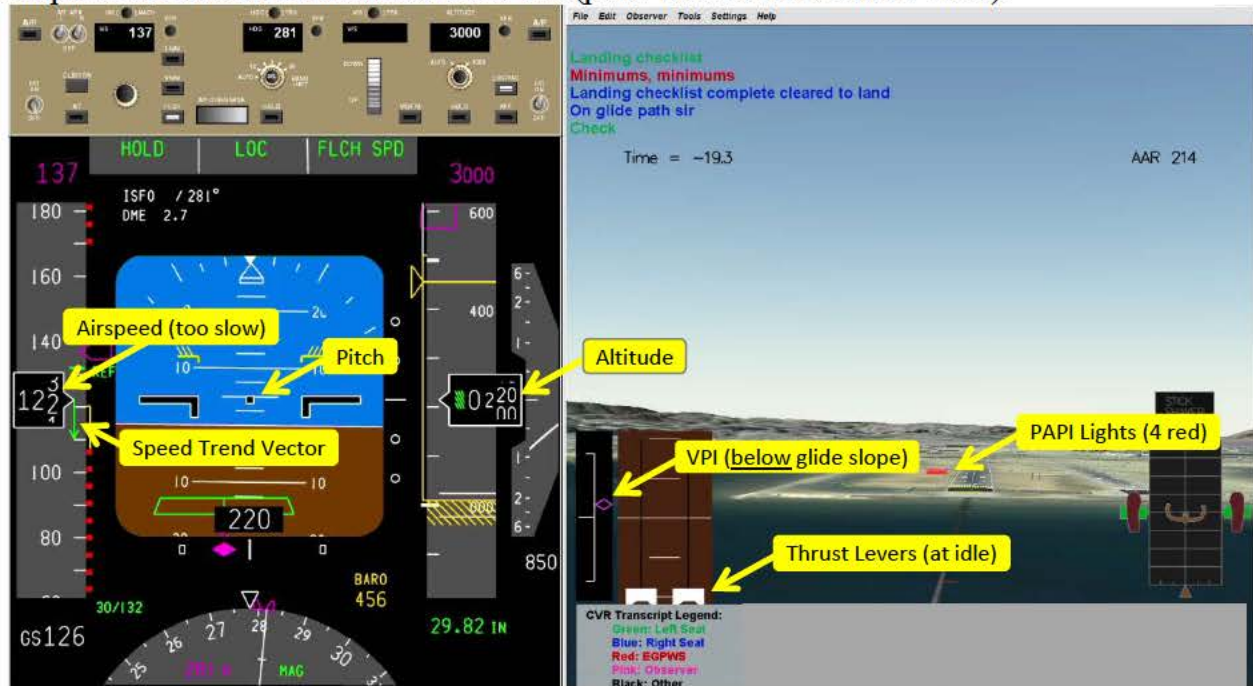
Snapshot of Backdrive Animation at 220 feet (point where PAPI showed 4 Red):

Discussion: At approximately 220 feet, the PAPI goes to 4 Red and the approach is more unstable, as shown in Table 2 (page 16). The PM said “*it's low,*” and the PF acknowledged with “*yeah*”. But the crew neither called for a go-around nor initiated one. None of the three pilots on the flight deck said anything about the throttles being at the idle stops or airspeed, which was 15 knots below the MCP selected speed. In his second interview, the PF said “he was worrying about the PAPI turning to four red lights because that meant he would fail his flight, and he would be very embarrassed if that occurred. He added that four red is a very dangerous situation to a pilot.”<sup>25</sup> Apparently recognizing that the airplane was below the glide path, the FDR data show the PF applied an unusual amount of aft column to pitch the airplane up.

During the NTSB public hearing, Asiana’s 777 Chief Pilot stated that, under Asiana’s policies, if a flight crew sees four red PAPI lights, they are required to perform an immediate go-around.<sup>26</sup>

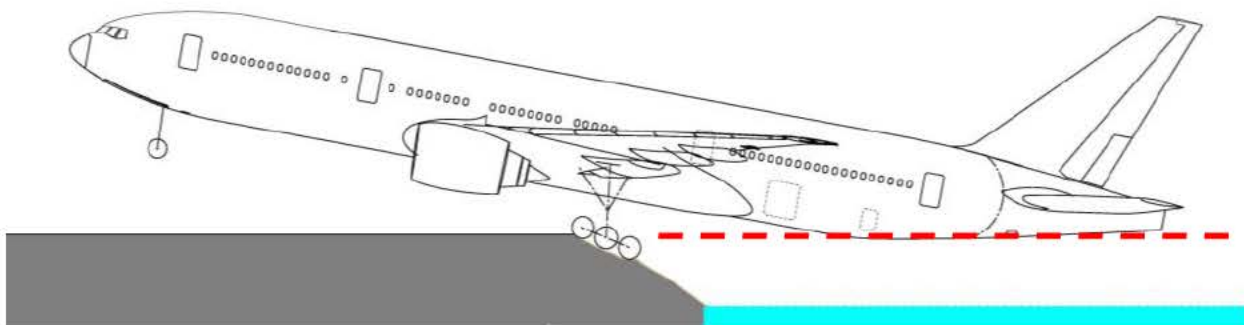
Estimated aircraft position at impact with the seawall

Discussion: The main landing gear were the first parts to contact the seawall, as shown below. Airspeed at impact was about 105 knots, and pitch attitude was 11-12 degrees. At impact, the control column was at the full aft stop, with a total of over 100 pounds of column force being exerted by both pilots combined.

The lowest recorded airspeed during the approach was 103 knots, which was 34 knots below the MCP selected airspeed of 137 knots. 137 knots is  $V_{REF} + 5$  knots, which was the correct airspeed for the approach.

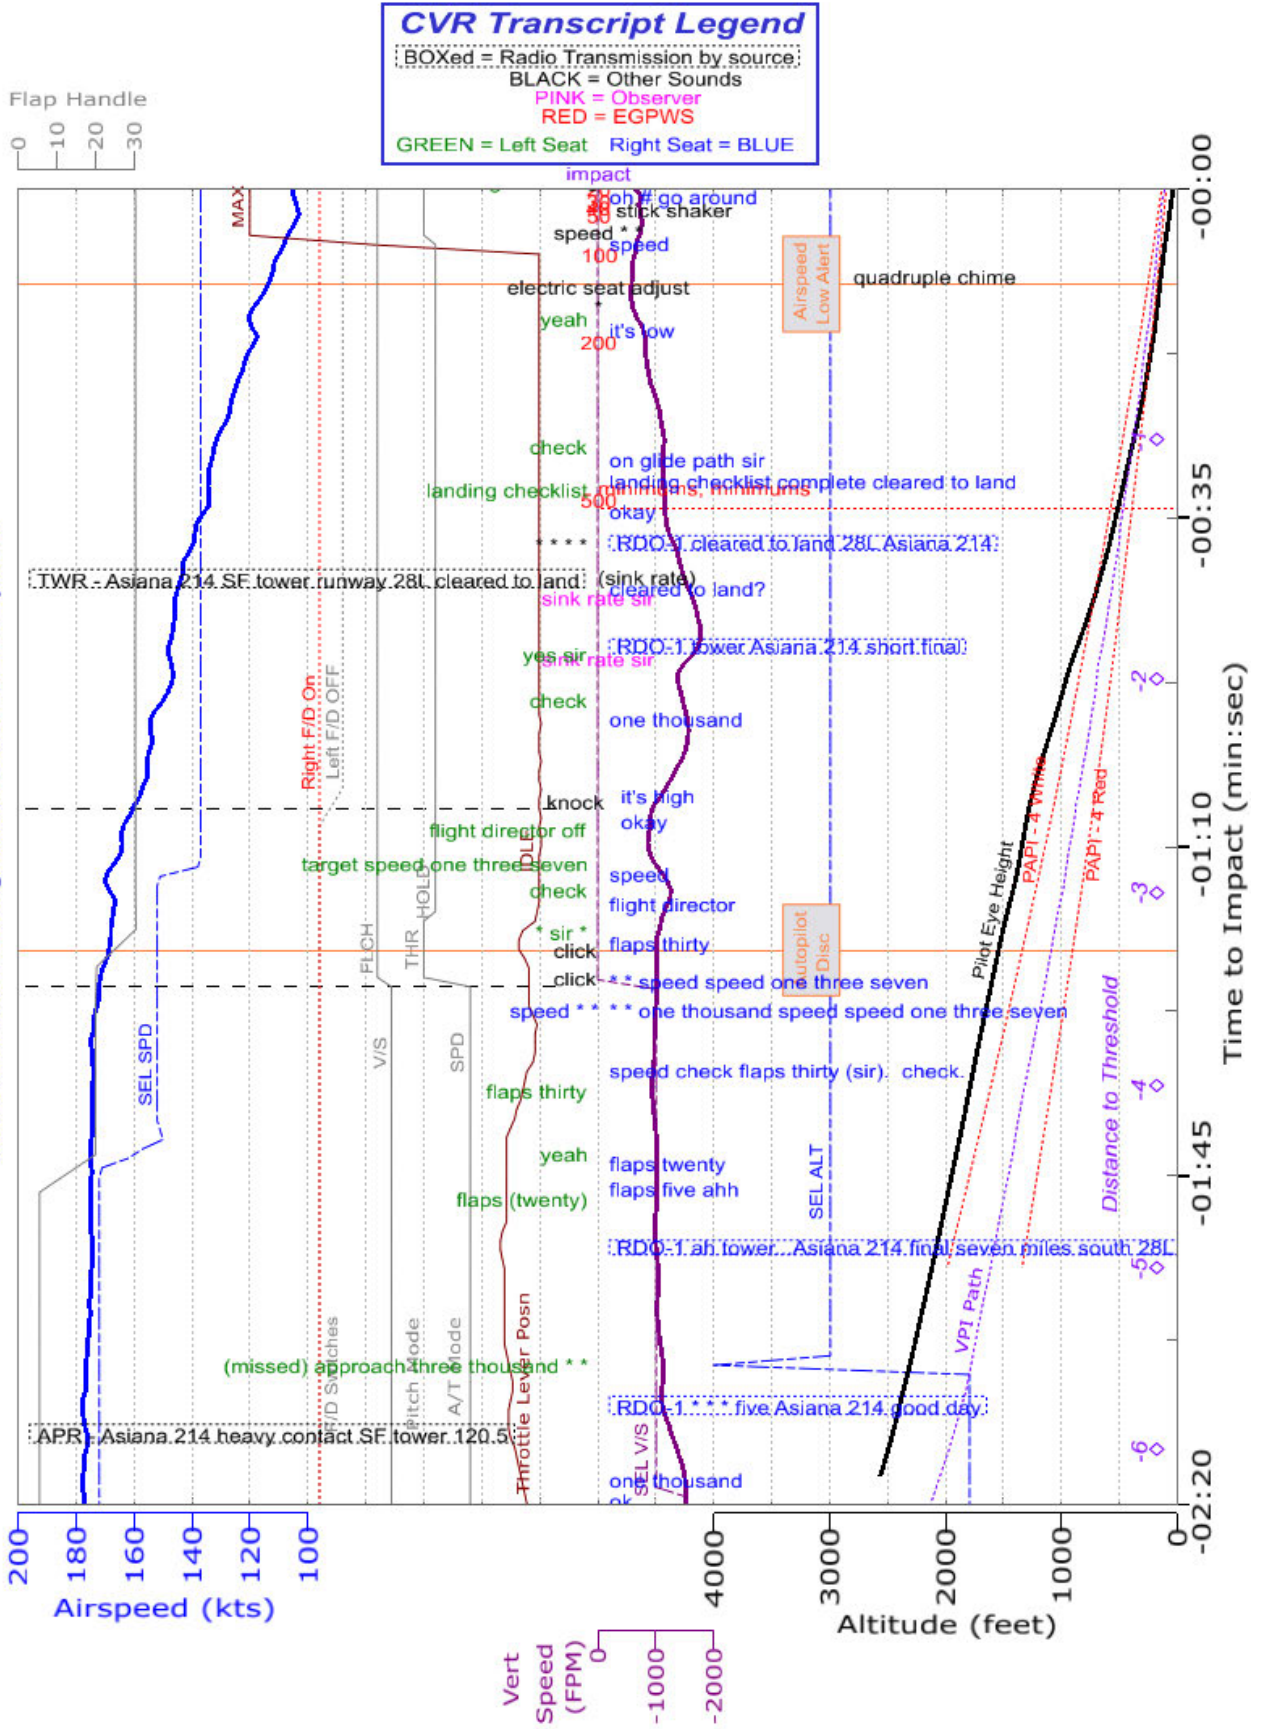
Plot 4 – FDR/CVR Overlay  
Final Approach – FLCH Button Push

Discussion: At about 1,600 feet the FDR data shows that the crew selected the autopilot's FLCH SPD mode. This action commanded the autopilot to climb, since the 3000 feet missed approach altitude had been set on the MCP. The selection of a FLCH SPD climb at this point was an action contrary to the crew's intent to land, the briefed approach, and Boeing's recommendations. In a post-accident interview the PF stated he considered pressing the FLCH pushbutton to obtain a higher descent rate but he could not recall what he did for sure.<sup>9</sup> The CVR recorded *sound of click* at the same time the FDR shows the FLCH SPD mode activated, which confirms that the button was pushed.

Neither the use of FLCH nor a climb after the FAF was part of the crew’s briefed landing.<sup>13</sup> Additionally, selection of FLCH at this point was contrary to Boeing’s guidance that “...the use of FLCH is not recommended after the FAF.”<sup>14</sup> Therefore, the FLCH button was erroneously pushed by the crew at about 1,600 feet, causing the airplane to attempt to climb.

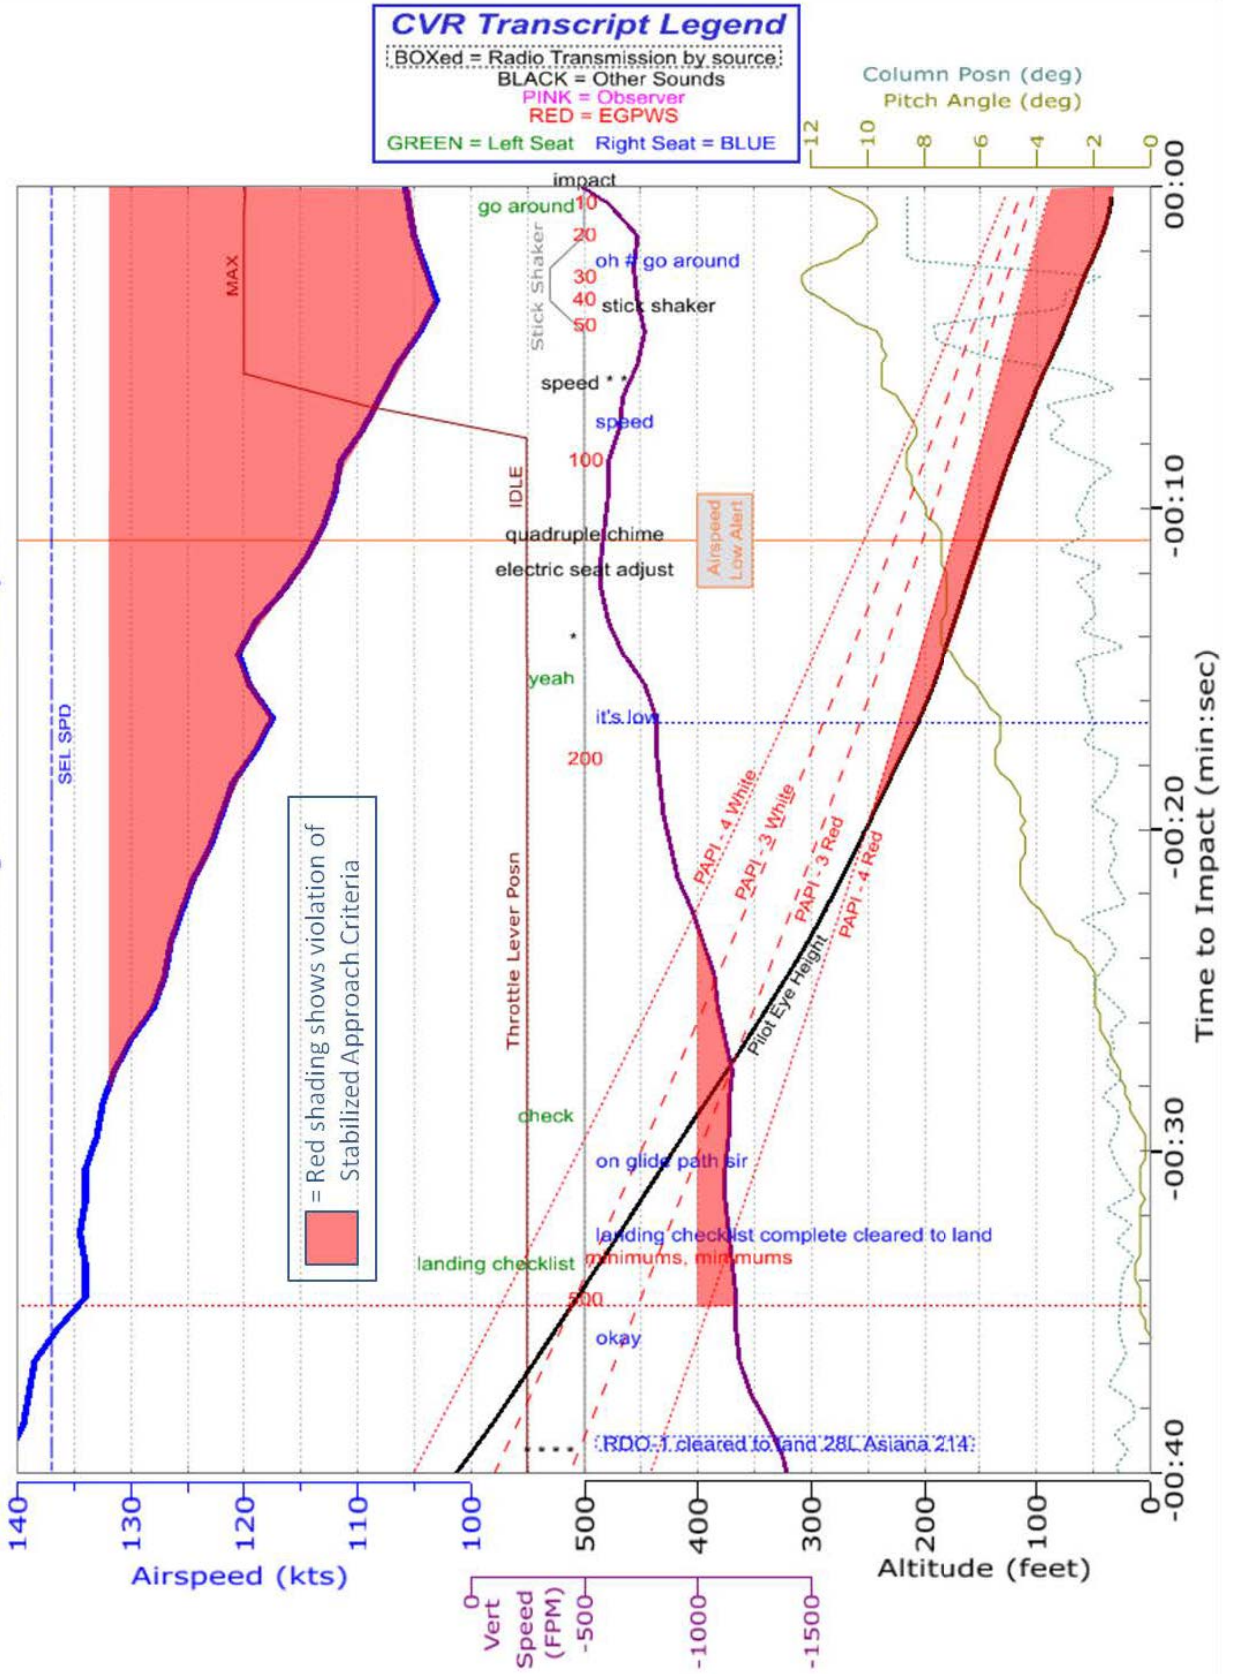
Plot 5 – FDR/CVR Overlay  
Final Approach from 500 feet

The PF was applying several degrees of aft column to pitch the airplane up as the airspeed decayed (see Plot 5). Aft column input is usually not needed until commencement of the flare maneuver, which is typically commenced below 50 feet. The FDR data also shows that no stabilizer trim was applied by the PF to relieve the force needed to pull the column. It is unusual for the pilot to have to pull back on the column in this manner, as pilots typically trim the aircraft. But no trim had been applied since the point the autopilot was disconnected more than a minute prior at 1,500 feet. Also, since the airspeed had decayed below the minimum maneuvering speed, the pilots couldn’t trim the aircraft and the force required to pull the column aft was progressively increasing. The inhibition of the trim function and increased column forces, both of which occur below minimum maneuvering speed, are designed as tactile clues that the airplane is below the minimum maneuvering speed.
