Subject: Boeing Submission for Asiana Airlines (AAR) 777-200ER HL7742  
Landing Accident at San Francisco – 6 July 2013

**Asiana 777-200ER – HL7742  
Landing Accident at San Francisco  
6 July 2013**

**The Boeing Company  
17 March 2014**

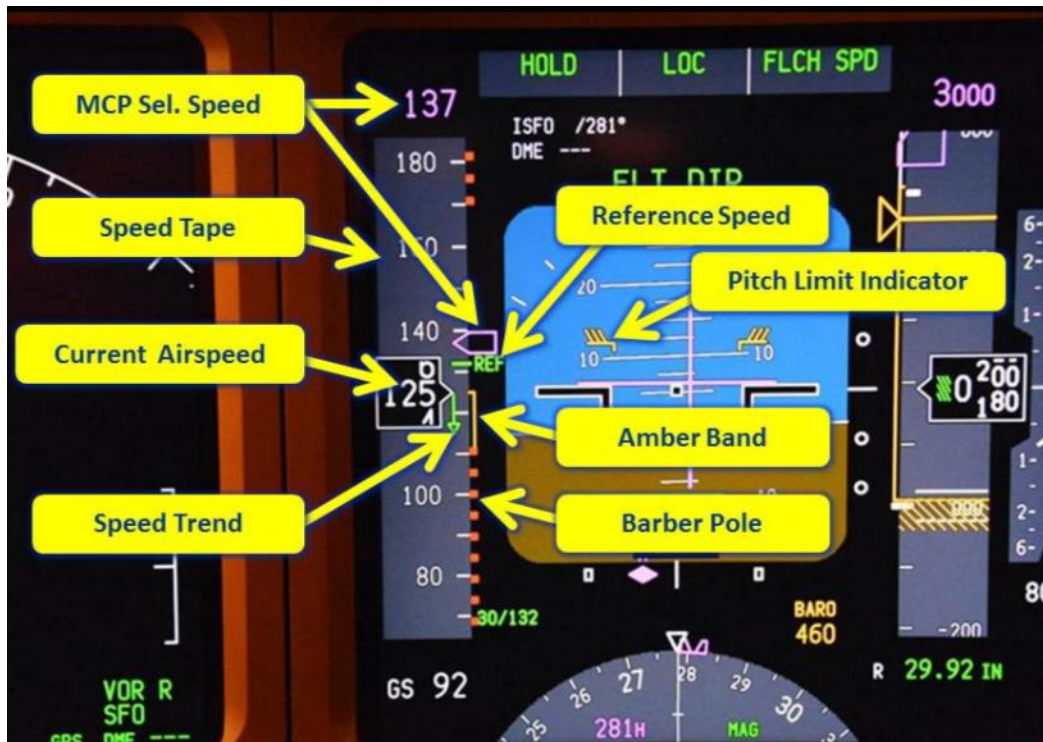
## Airspeed Cues (continued)

- The MCP selected speed, which appears both as digits and as a “bug” on the speed tape.
- The speed tape, which moves up and down as airspeed changes providing pilots with a sense of how quickly speed is changing.
- The current airspeed displayed with rolling digits, provides a sense of rate of change of speed.
- The speed trend vector, which indicates what the airspeed will be in 10 seconds.
- $V_{REF}$  “bug” on the speed tape, indicating the  $V_{REF}$  speed.
- The amber band, where top of amber band is minimum maneuvering speed, bottom of amber band is at the barber pole.
- The “barber pole,” indicating the stick shaker activation speed.
- The pitch limit indicator, indicating the pitch angle at which stick shaker will activate.<sup>72</sup>

In addition to the visual cues that the speed was decreasing, the aircraft also provided the crew with tactile cues that airspeed was decreasing below the minimum maneuvering speed. Stabilizer trim is inhibited when airspeed falls below the top of the amber band, which represents minimum maneuvering speed. Additionally, the force required to pull back on the column begins to increase considerably the slower the aircraft becomes.<sup>73</sup> All of these features are designed to provide a tactile cue that the airspeed is dropping below the minimum maneuvering speed. Prior to impact, the force exerted by the PF to increase the aircraft’s pitch was steadily increasing. At impact, the control column was at the full aft stop, with a total of over 100 pounds of column force being applied by both pilots combined.<sup>74</sup>
